Report Number: ESP014366P
Element Certification #: 12-0514.11
DC Not. #: 13020

STRUCTURAL PERFORMANCE TEST REPORT

Product Type and Series: Series 145.095 SS Vinyl (NC) Fin & (Rep) Equal Leg Frame Impact Glass Horizontal Sliding Window

Tests Conducted: TAS 201 (Large Missile), TAS 202, and TAS 203

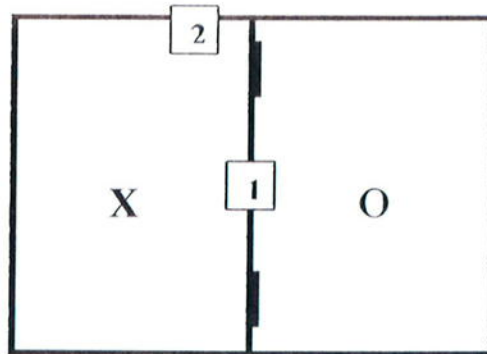
Measurement Locations

Deflection / Permanent Set were measured with two (2) Mitutoyo dial indicators SN- A066, and SN – A070

Measurements were taken at:

Location (1) - Max. Allowable Perm. Set after test load at center mid-span of the fixed meeting stile.(0.4% of (57.00”) span) = (0.228”)

Location (1) - Max. Allowable Perm. Set after test load at longest unsupported span between installation fasteners frame head.(0.4% of (12.00”) span = (0.048”)

Location (1) - Max. Allowable Perm. Set after test load at center mid-span of the fixed meeting stile.(0.4% of (57.00") span = (0.228")

Location (1) - Max. Allowable Perm. Set after test load at longest unsupported span between installation fasteners frame head.(0.4% of (12.00") span = (0.048")

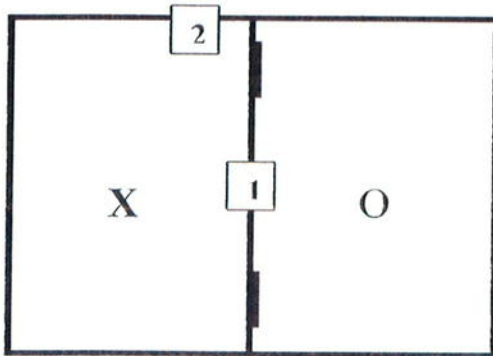
Location (1) - Max. Allowable Perm. Set after test load at center mid-span of the fixed meeting stile.(0.4% of 1556 mm (57.00") span) = 6.2 mm (0.228")

Location (1) - Max. Allowable Perm. Set after test load at longest unsupported span between installation fasteners frame head.(0.4% of 305 mm (12.00") span) = 6.2 mm (0.048")

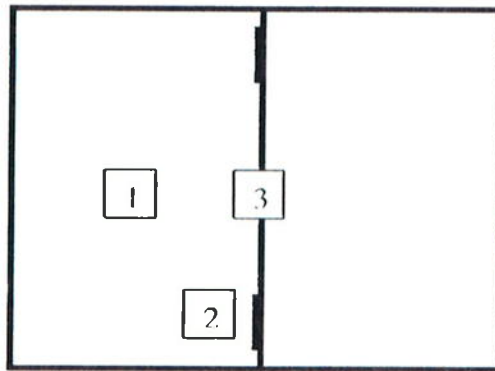
Specimen 3

Each specimen was impacted with an 8 ft., 9 lb. Southern yellow pine 50mm x 100mm (2" x 4") at the following locations:

X measurement from left edge of specimen.

Y measurement from top edge of test specimen.

Specimen	X Impact Loc.	O Speed Ft/Sec	X Meas.	Y Meas.
No. 3	Loc: 1.	50.1	16.750"	31.500"
	Loc: 2.	50.0	27.000"	52.000"
	Loc: 3.	50.0	36.250"	31.000"

Results: All specimens tested resisted the large missile impact, without penetration of the inner plane of the glazing. With no tear forming longer than 5" and wider than 1/16" thru which air can pass, or no opening through which a 3" diameter solid sphere could freely pass.

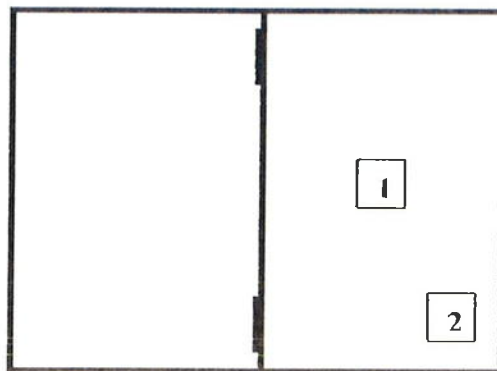
Specimen 4

Specimen	X Impact Loc.	O Speed Ft/Sec	X Meas.	Y Meas.
No. 4	Loc: 1.	50.0	53.000"	32.000"
	Loc: 2.	50.1	63.000"	51.750"

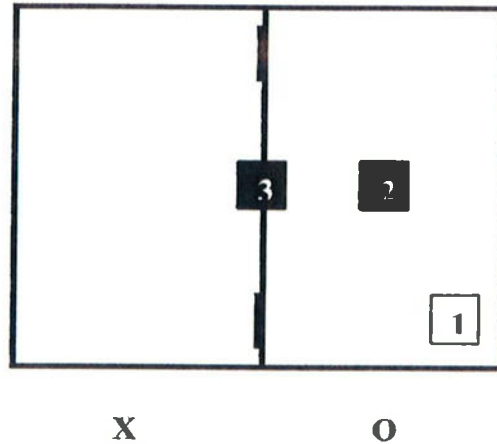
Specimen 5

<u>Specimen</u>	<u>Impact Loc.</u>	<u>Speed Ft/Sec</u>	<u>X Meas.</u>	<u>Y Meas.</u>
No. 5	Loc: 1.	50.0	63.500"	52.000"
	Loc: 2.	49.9	53.500"	31.000"
	Loc: 3.	50.0	36.000"	30.250"

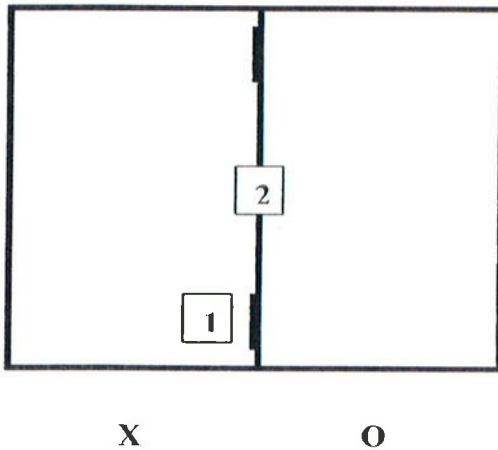
Specimen 6

Each specimen was impacted with an 8 ft., 9 lb. Southern yellow pine 50mm x 100mm (2" x 4") at the following locations:

X measurement from left edge of specimen.

Y measurement from top edge of test specimen.

Impact No.	Impact Loc.	Speed Ft/Sec.	X Meas.	Y Meas.
1.	1	50.1	26.750"	51.500"
2.	2	50.1	36.250"	31.500"

Results: All specimens tested resisted the large missile impact, without penetration of the inner plane of the glazing. With no tear forming longer than 5" or no opening through which a 3" diameter solid sphere could freely pass.
