Report Number: ESP010311P-5
CTL Certification #: 05-0314.01
DC Not. #: 12004

STRUCTURAL PERFORMANCE TEST REPORT

Product Type and Series: Series 143.191CA-008 Vinyl NC (Fin) Frame Impact Casement Window (37" x 76")

Tests Conducted: TAS 201 (Large Missile), TAS 202, and TAS 203

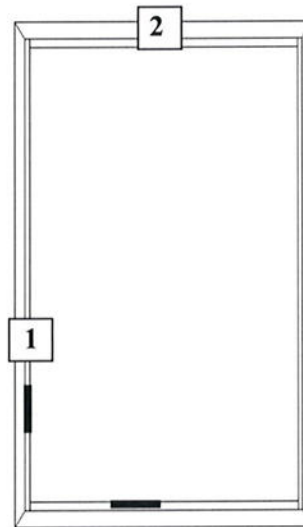
Measurement Locations

Deflection / Permanent Set were measured with two (2) Mitutoyo dial indicators SN- mky019, and SN - mtj695
 Measurements were taken at:

- Location 1 Longest unsupported span between the keepers on the sash side like stile
 (18” x 0.004” = 0.072”allowable)
- Location 2 Longest unsupported span between the keepers on the sash bottom rail.
 (35.25” x 0.004” = 0.141”allowable)

Location (1) - Max. Allowable Perm. Set after test load at the longest unsupported span between the keepers on the sash side lock stile (0.4% of 530mm (18.000") span) = 2.1mm (0.072")

Location (2) - Max. Allowable Perm. Set after test load at the longest unsupported span between the keepers on the sash top lock rail (0.4% of 584mm (35.250") span) = 2.3mm (0.141")

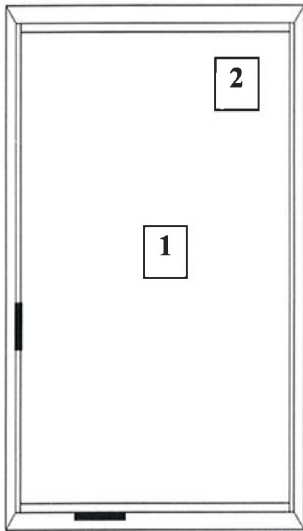
Specimen 2

Each specimen was impacted with an 8 ft., 9 lb. Southern yellow pine 50mm x 100mm (2" x 4") at the following locations:

X measurement from left edge of specimen.

Y measurement from top edge of test specimen.

Impact No.	Speed ft/sec.	X Meas.	Y Meas.
1.	50.2	17.500"	37.500"
2.	50.3	28.000"	9.500"
