STERGIS WINDOWS AND DOORS, INC. ACOUSTICAL PERFORMANCE TEST REPORT

ASTM E90 SOUND TRANSMISSION LOSS TESTING ON A WINDGATE, DOUBLE HUNG WINDOW

REPORT NUMBER I2143.01-113-11-R0

TEST REPORT FOR STERGIS WINDOWS AND DOORS, INC.

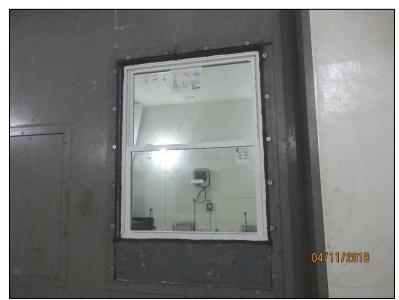
Photo No. 1 Receive Room View of Installed Specimen

The specimen plug was removed from the filler wall assembly. A filler wall-reducing element, consisting of two separate 2x6 wood frames filled with concrete, was used to adjust the test opening size to accommodate the test specimen. A dense neoprene gasket was placed between the two wood and concrete frames. The specimen was placed on an isolation pad in the custom test opening. Duct seal was used to seal the perimeter of the specimen to the test opening on both sides. The interior side of the specimen, when installed, was approximately 1/4" from being flush with the receive room side of the filler wall. A stethoscope was used to check for any abnormal air leaks around the test specimen prior to testing. Operable portions of the test specimen, if any, were cycled at least five times prior to testing.

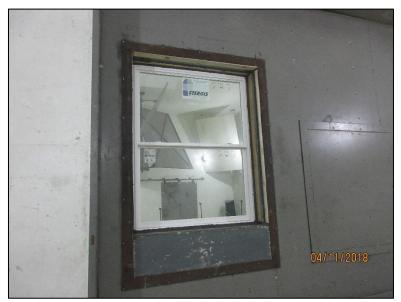
Photo No. 2 Source Room View of Installed Specimen
