Report Number: ESP101311P-7
CTL Certification #: 05-0314.01
DC Not. #: 12004

STRUCTURAL PERFORMANCE TEST REPORT

Product Type and Series: Series 143.191CA-008 Vinyl Equal Leg Frame Impact Casement Window (37" x 76")

Tests Conducted: TAS 201 (Large Missile), TAS 202, and TAS 203

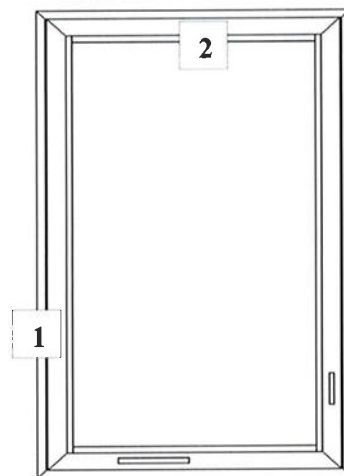
Measurement Locations

Deflection / Permanent Set were measured with two (2) Mitutoyo dial indicators SN- mky019, and SN - mtj695
 Measurements were taken at:

- Location 1 Longest unsupported span between the keepers on the sash side like stile (18” x 0.004” = 0.072”allowable)
- Location 2 Longest unsupported span between the keepers on the sash bottom rail. (35.25” x 0.004” = 0.141”allowable)

Location (1) - Max. Allowable Perm. Set after test load at the longest unsupported span between the keepers on the sash side lock stile (0.4% of 530mm (18.000") span) = 2.1mm (0.072")

Location (2) - Max. Allowable Perm. Set after test load at the longest unsupported span between the keepers on the sash top lock rail (0.4% of 584mm (35.250") span) = 2.3mm (0.141")

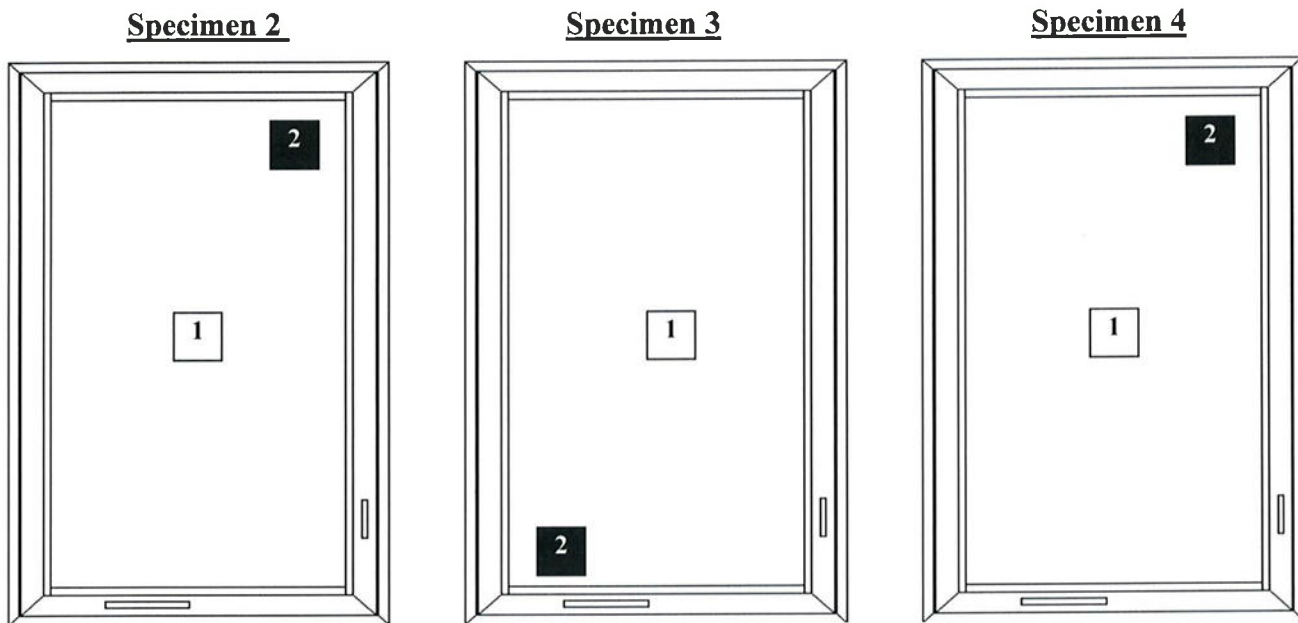
Each specimen was impacted with an 8 ft., 9 lb. Southern yellow pine 50mm x 100mm (2" x 4") at the following locations:

Specimens 2, 3, & 4

X measurement from left edge of specimen.

Y measurement from top edge of test specimen.

Impact No.	Impact Loc.	Speed Ft/Sec.	X Meas.	Y Meas.
1.	1	50.0	17.000"	38.500"
2.	2	50.3	26.000"	10.500"

Impact No.	Impact Loc.	Speed Ft/Sec.	X Meas.	Y Meas.
1.	1	50.1	18.500"	37.000"
2.	2	50.2	10.000"	63.000"

Impact No.	Impact Loc.	Speed Ft/Sec.	X Meas.	Y Meas.
1.	1	49.9	18.000"	36.500"
2.	2	50.1	25.500"	9.500"
