Report Number: ESP009160P  
Report Date: April 23, 2012

## STRUCTURAL PERFORMANCE TEST REPORT

Specimen 1 Series 623.620PD-005 Vinyl Equal Leg Frame Impact Sliding Glass Door  
(192.00" x 96.00")

Specimens 2 & 3 Series 623.620PD-005 Vinyl Fin Frame Impact Sliding Glass Door  
(192.00" x 96.00")

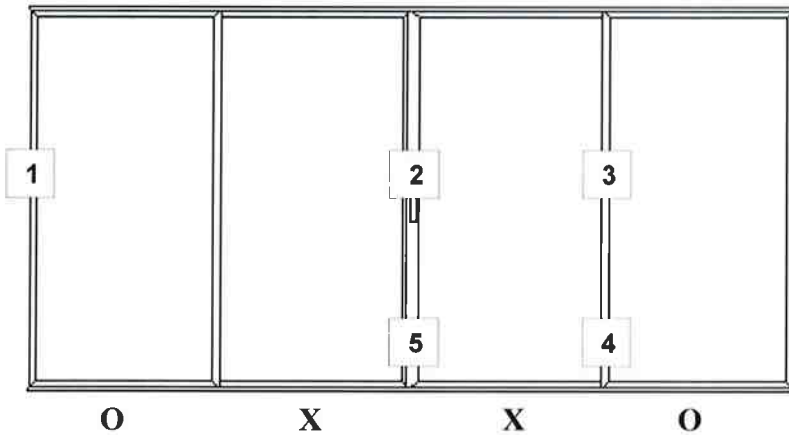
#### Measurement Locations

Deflection / Permanent Set were measured with five (5) CDI Dial Indicators

- Location (1) -Center mid-span of frame jamb fasteners
- Location (2) -Center mid-span of the astragal/operable panel
- Location (3) -Center mid-span of the fixed/operable panel interlock
- Location (4) (2") from bottom of the fixed/operable panel interlock
- Location (5) (2") from bottom of the astragal/operable panel

<u>Deflection @ Design</u>	<u>Set @ Test</u>	<u>Allowable Set</u>
D/P @ 2403 Pa. (50.0 psf.)	Loc. 2	(1.490")	(.054")	(0.384")
Test pressure @ 3345 Pa. (75.0 psf.)	Loc. 3	(1.130")	(.190")	(0.384")

D/P @ 2403 Pa. (50.0 psf.)	Loc. 2	(1.658")	(.075")	(0.384")
Test Pressure @ 3345 Pa. (75.0 psf.)	Loc. 3	(1.320")	(.130")	(0.384")

Location (2): Maximum allowable permanent set after test load at center mid-span of exterior left interlock stile:  
 (0.4% of (96") span) = (0.384")  
 Location (3): Maximum allowable permanent set after test load at center mid-span of exterior right interlock stile:  
 (0.4% of (96") span) = (0.384")

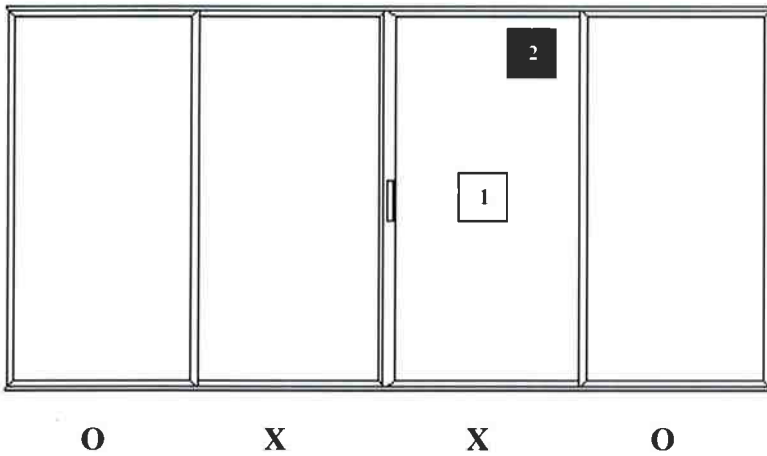
**Specimen 1'**

Specimens were tested to ASTM E 1996-05 with the required protocol of the test specifications. All specimens were tested to the Wind Zone 4 requirements stated in section 5 of ASTM E-1996-05 Missile level D. The missile orientation was perpendicular to the glazing surface at impact. Each specimen was impacted with an 8 ft., 9 lb. Southern yellow pine 2" x 4" at the following locations:

X- Measurement from left edge of test specimen.

Y- Measurement from top edge of test specimen.

<b>Specimen 1:</b>	<u>Impact No.</u>	<u>Speed ft/sec.</u>	<u>X Meas.</u>	<u>Y Meas.</u>
	1.	50.0	123.000"	48.500"
	2.	49.9	134.500"	14.000"

When evaluated, upon completion of missile impacts the test specimens resisted the large missile impacts with no tear formed longer than (5 in.) by (1/16 in.) wide through which air can pass.

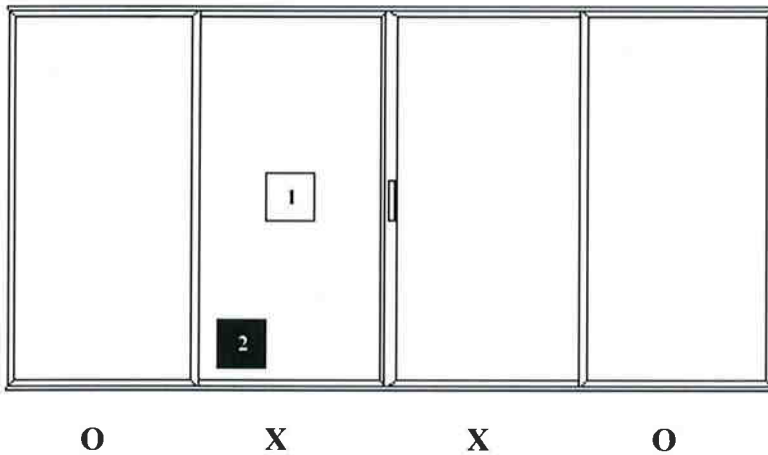
**Specimen 2**

Specimens were tested to **ASTM E 1996-05** with the required protocol of the test specifications. All specimens were tested to the Wind Zone 4 requirements stated in section 5 of **ASTM E-1996-05** Missile level D. The missile orientation was perpendicular to the glazing surface at impact. Each specimen was impacted with an 8 ft., 9 lb. Southern yellow pine 2" x 4" at the following locations:

X- Measurement from left edge of test specimen.

Y- Measurement from top edge of test specimen.

<b>Specimen 2:</b>	<u>Impact No.</u>	<u>Speed ft/sec.</u>	<u>X Meas.</u>	<u>Y Meas.</u>
	1.	50.2	74.000"	49.000"
	2.	50.1	59.500"	79.500"

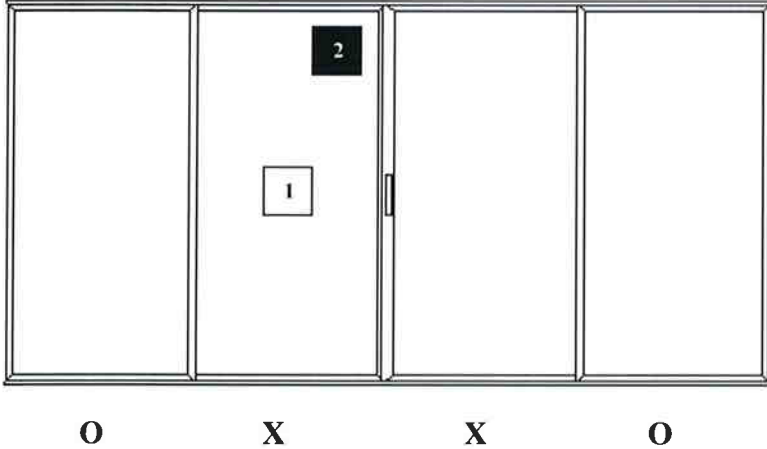
**Specimen 3**

**Specimen 3: ASTM E-1996-05 (With Deviations Only) (2) Fin Frame Specimens Were Impacted Reference Test Report CTLA 2054W for Additional Impact).**

<b>Specimen 3:</b>	<u>Impact No.</u>	<u>Speed ft/sec.</u>	<u>X Meas.</u>	<u>Y Meas.</u>
	1.	50.0	75.000"	50.000"
	2.	50.1	86.500"	12.000"

When evaluated, upon completion of missile impacts the test specimens resisted the large missile impacts with no tear formed longer than (5 in.) by (1/16 in.) wide through which air can pass.
